EA94-022

**CALSPAN EVALUATION OF FORD CROWN VICTORIA POLICE VEHICLE
STEERING FAILURE ALLEGATIONS**

SYNOPSIS : CERTAIN VEHICLE MANEUVERS AT LOW SPEEDS, ESPECIALLY THOSE WHICH MAY BE ENCOUNTERED IN POLICE PRECISION PURSUIT, MAY CAUSE TEMPORARY LOSS OF POWER STEERING ASSIST AND ADVERSELY AFFECT VEHICLE CONTROLLABILITY.

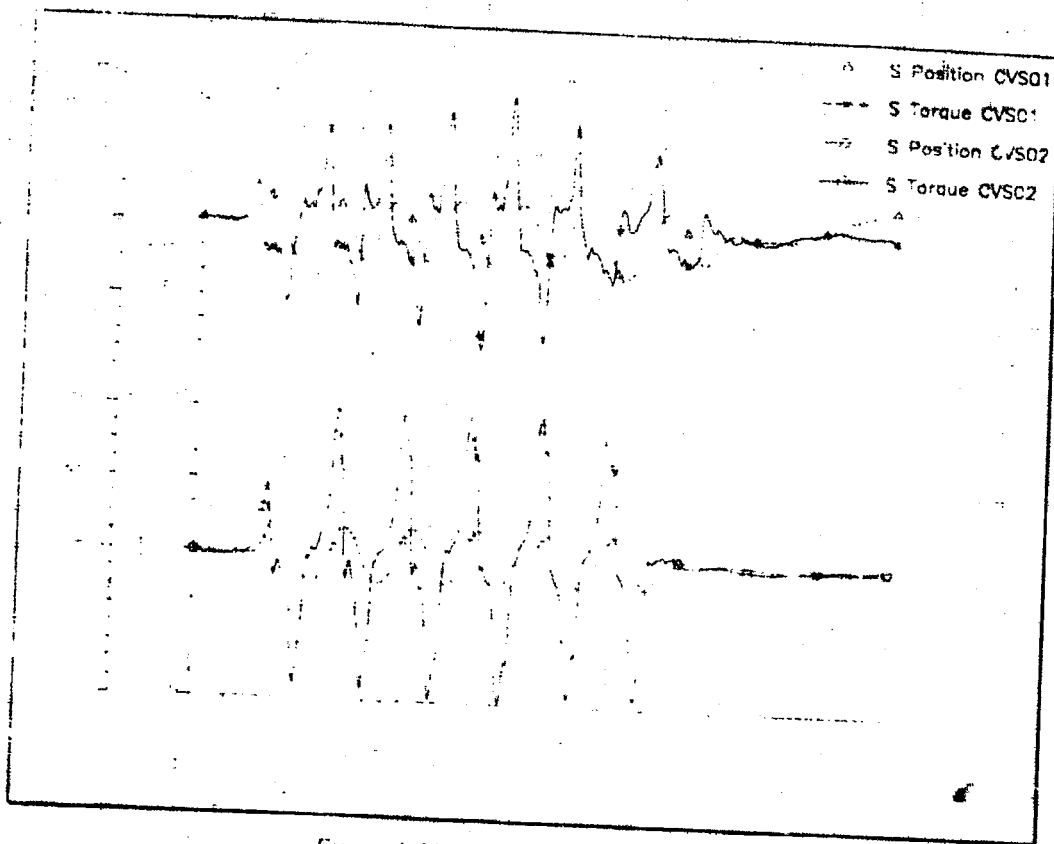
Figure 4 -Vehicle 1 Serpentine 01-02

Figures 4 and 5 depict the same data wherein the steering wheel position and applied torque are plotted along a common axis. An examination of these figures reveals that the applied steering wheel torque exceeded 8 ft-lbs (minimum limit of supertorque) repeatedly during the tests.

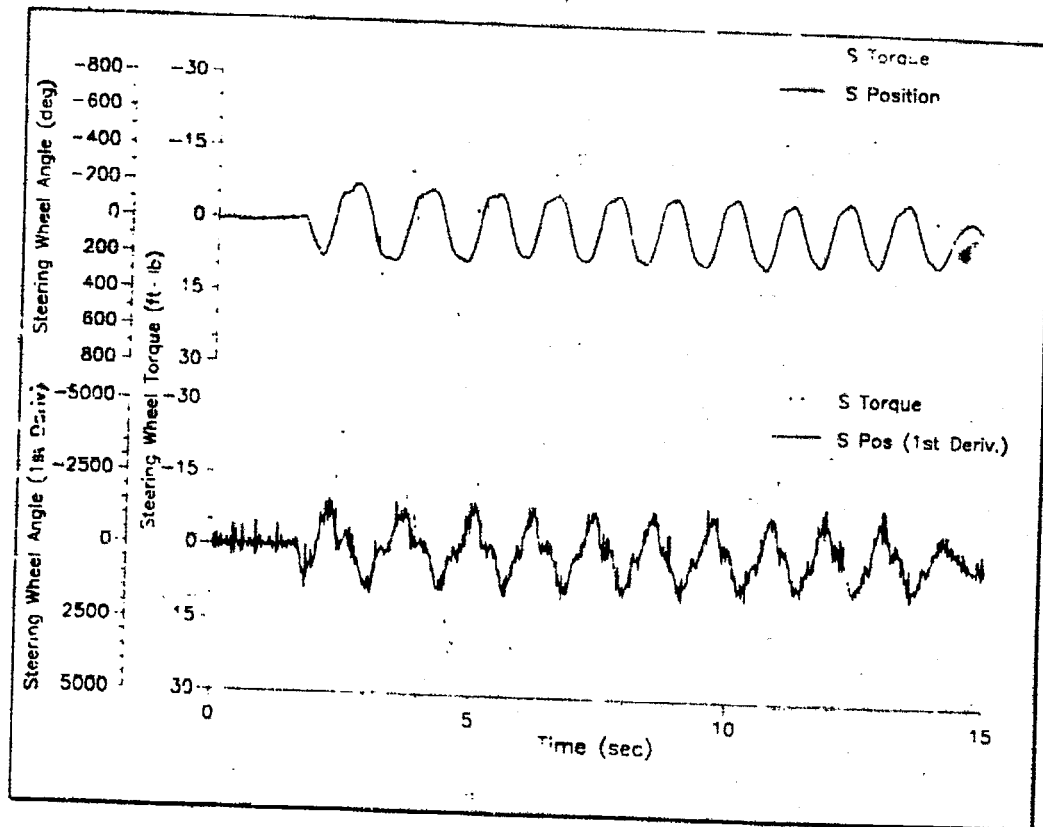
Figure 7 -Vehicle 5 Serpentine 22 Derivative

common axis. The decrease in the angular velocity of the steering wheel during periods of peak supertorque, observed in the lower graph of this figure, is more pronounced than in Figure 6. Also more pronounced in Figure 7 is the notched appearance of the torque curve near each maximum. This "kick-back" coincides with a sudden slowing of the wheel which is also noticeable as a flattening of steering wheel position curve in the upper graph. This indicates that the steering wheel was beginning to stop in spite of the high supertorque. Driver B (See Figure 7) is not as physically strong as Driver A (See Figure 6). Driver A was apparently able to prevent the "kick-back" of the steering wheel on all but one occasion (near 11 seconds in Run CVS04).

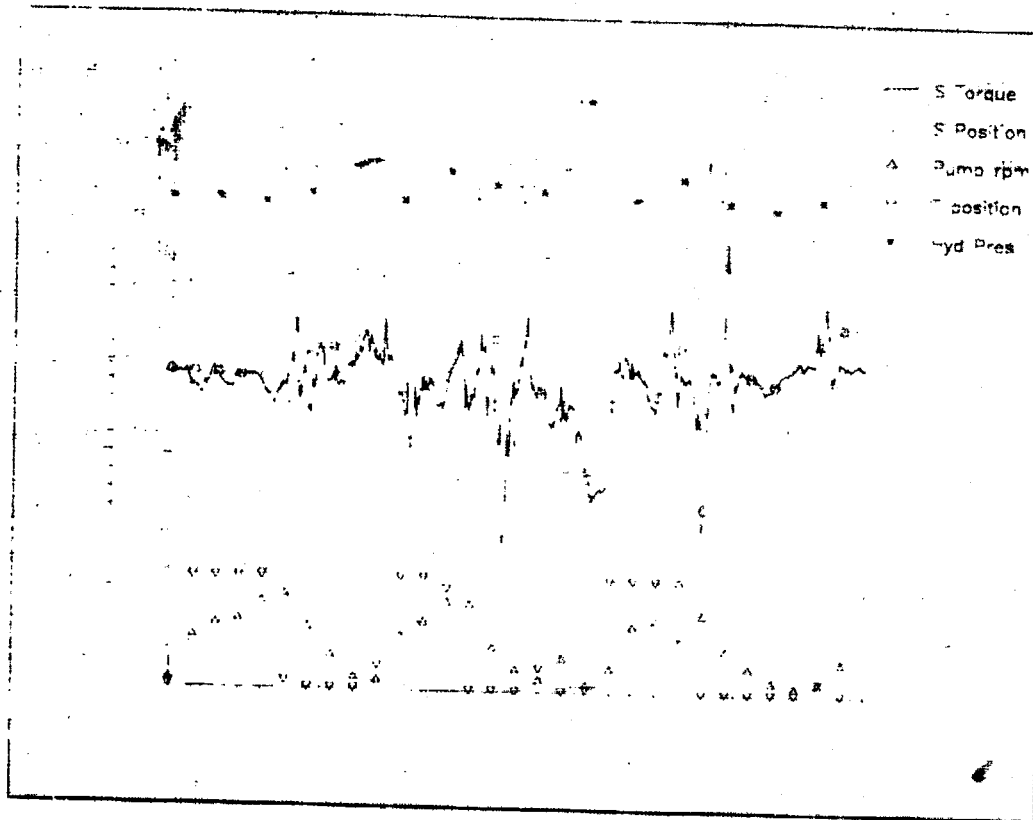
Figure 8 -Vehicle 1 Pursuit Course 08

Figure 8 contains graphs of the time history data of steering wheel position, applied steering wheel torque, throttle position, power-steering pump shaft speed, and power-steering pump outlet pressure for Run CVS08. Figures 9 and 10 contain the same information for Runs CVS16 and CVS20 respectively.

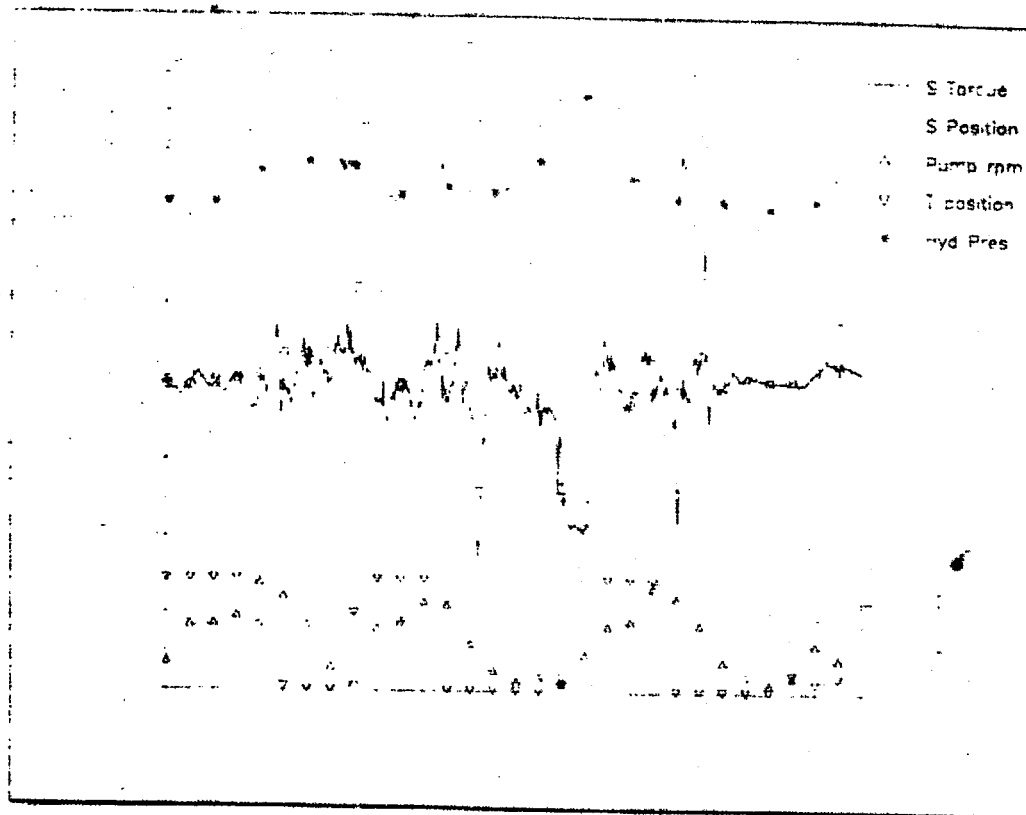
Figure 9 - Vehicle 1 Pursuit Course 16

shaft speed were low. Looking at the supertorque event that occurred at about 23 seconds, it is apparent that the pump shaft speed is about 3700 rpm. This would indicate that although low engine speed would exacerbate the condition, it is not the primary cause of the subject steering condition.

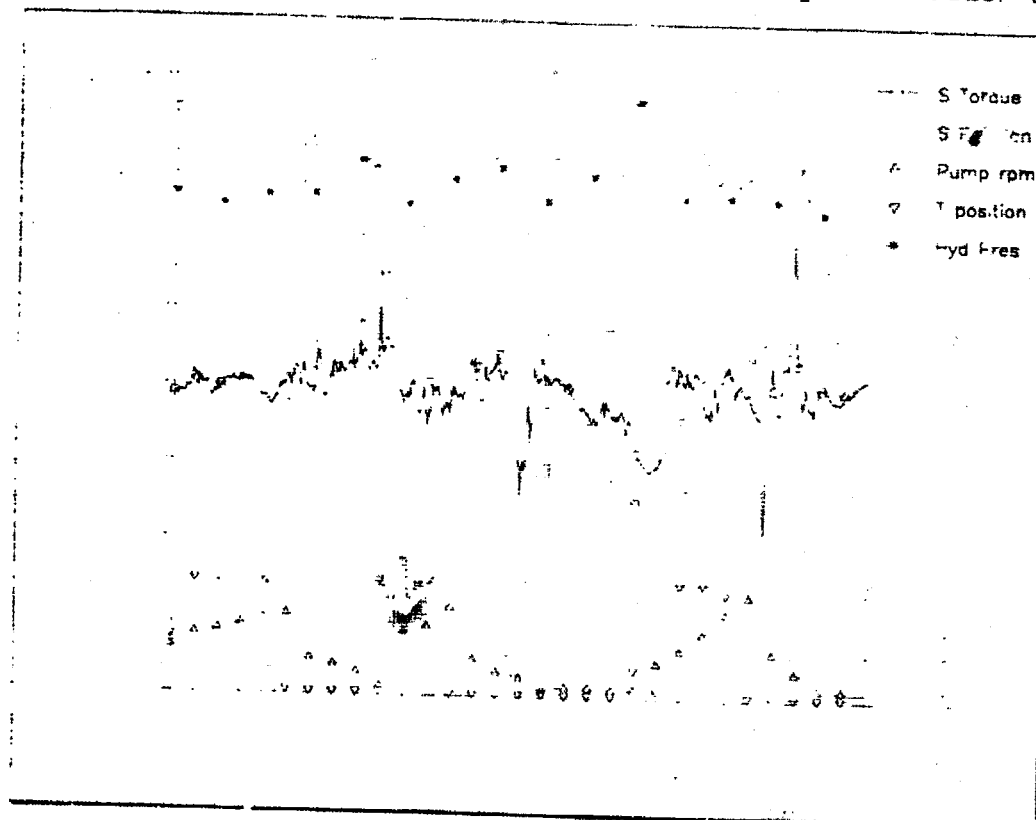
Figure 10 - Vehicle 1 Pursuit Course 20

An examination of Figure 10 reveals supertorque events still occurred even though the EVO assembly was disconnected. This run was also driven more slowly (elapsed time about 29 seconds) than Runs 08 and 16 (elapsed times about 26 and 25 seconds respectively). The response rate of the EVO system could exacerbate the condition by failing to quickly switch to the maximum assist state. Since the EVO assembly was electrically disconnected (power-steering pump should remain in maximum assist state) during Run CVS20, the

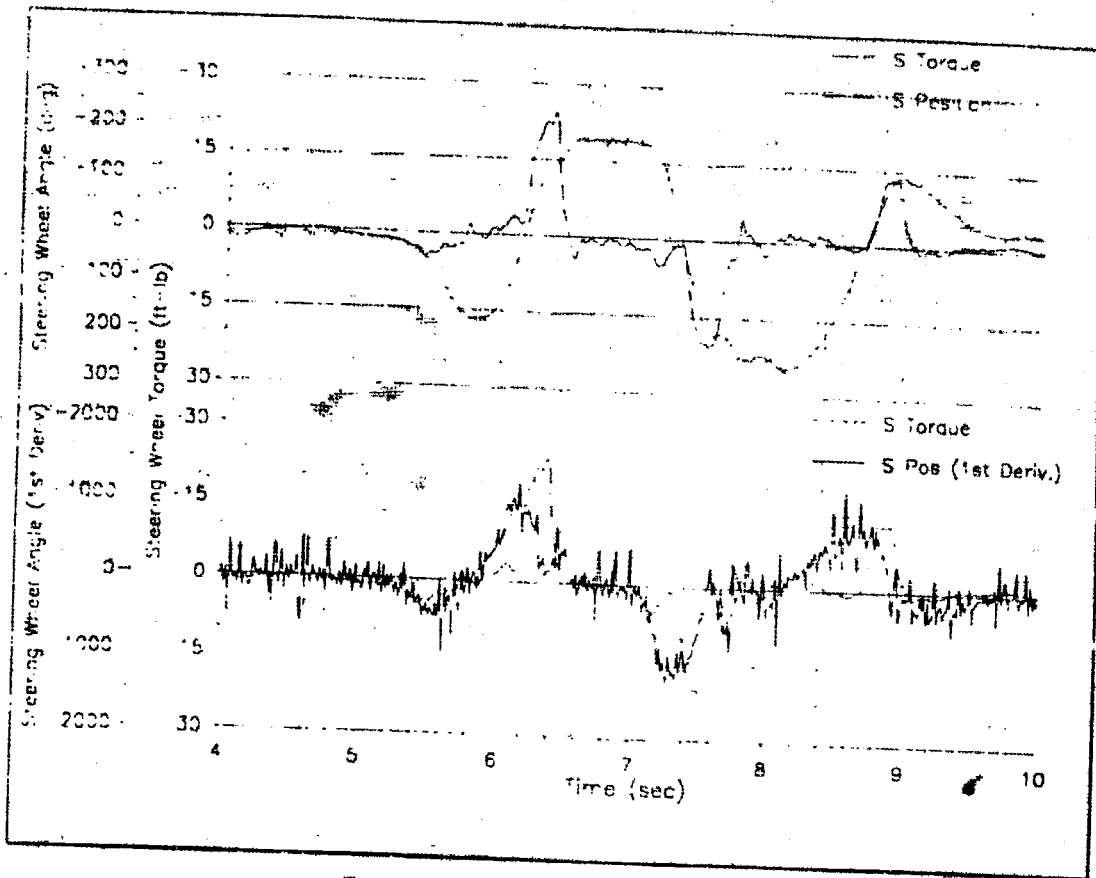
Figure 15 -Vehicle 5 50-ft Slalom 41

Figure 15 contains graphs of data and data calculations for Run CVD41. The upper graph is the time history of applied torque and steering wheel position plotted along a common axis. The lower graph is the time history of applied torque and the calculated steering wheel angular velocity plotted along a common axis.

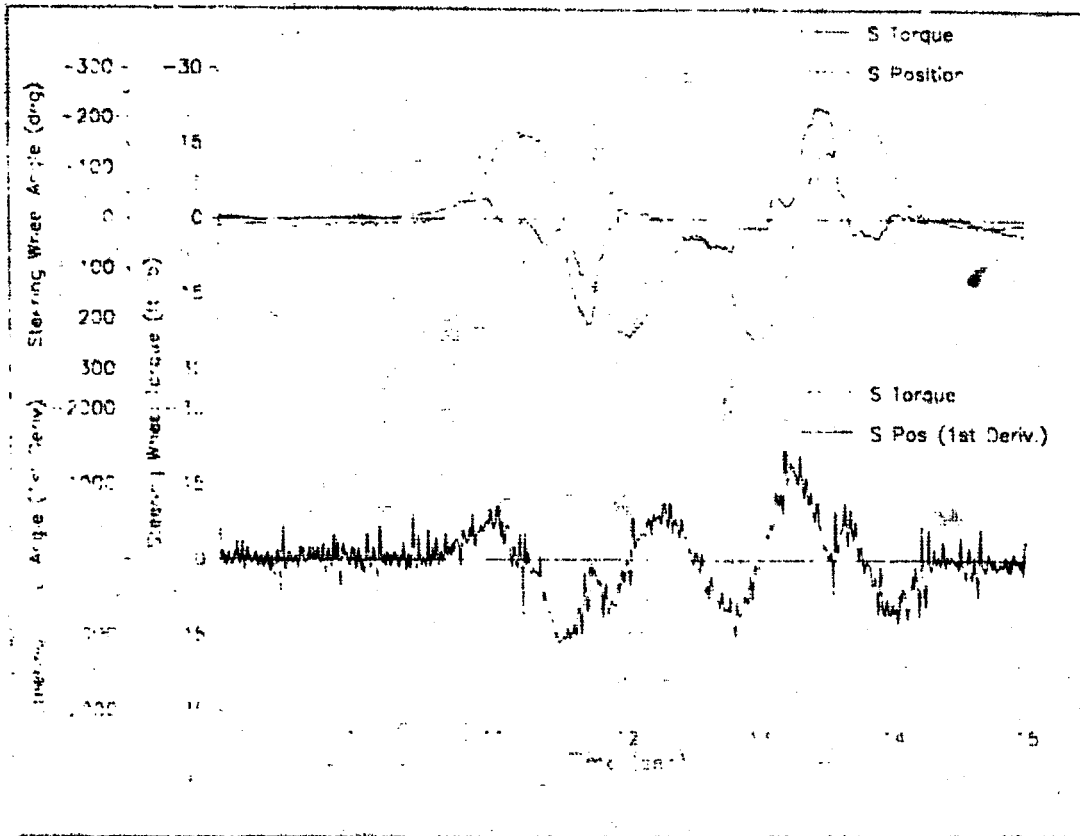
Fig. 19. CVD89 - Steering Wheel Data

Figure 19 contains graphs of data and data calculations for Run CVD89. The upper graph is the time history of applied torque and steering wheel position plotted along a common axis. The lower graph is the time history of applied torque and the calculated steering wheel angular velocity plotted along a common axis.
