**CALSPAN EVALUATION OF FORD CROWN VICTORIA
POLICE VEHICLE STEERING FAILURE ALLEGATIONS**

CALSPAN CRASH INVESTIGATION REPORT
CALSPAN CASE NO. 94-33
VEHICLE: 1992 FORD CROWN VICTORIA POLICE UNIT
LOCATION: SCARBOROUGH, ONTARIO (CANADA)
DATE : SEPTEMBER 28, 1994

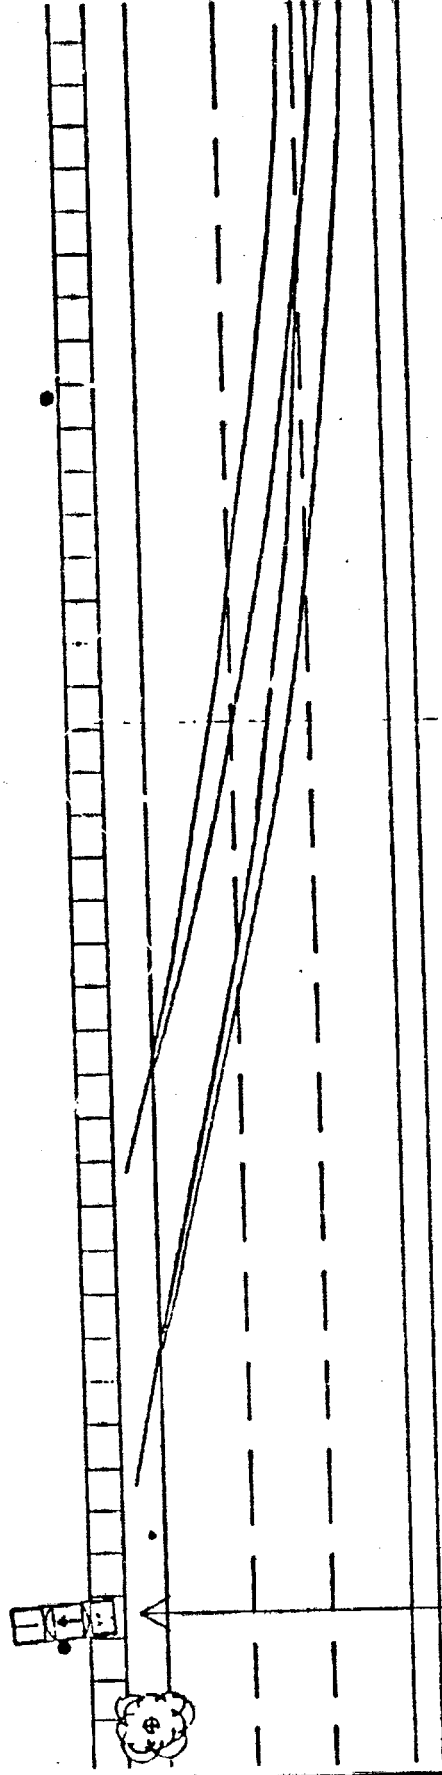
VEHICLE #1 STARTS TO OVERTURN
AND STRIKES PEPCO POLE

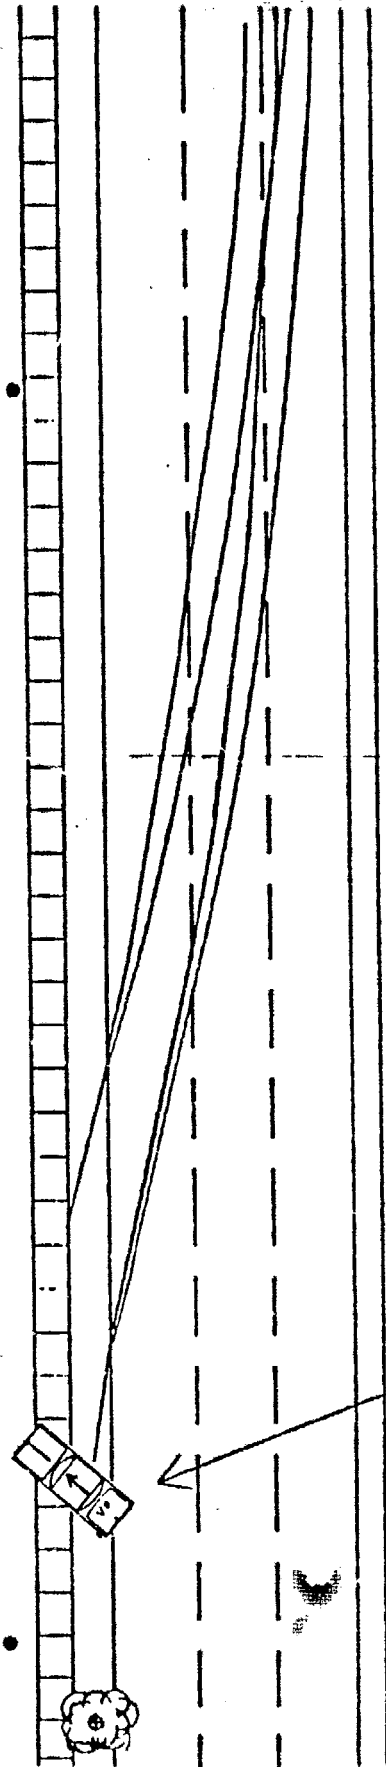
VEHICLE #1 STRIKES FIRE HYDRANT

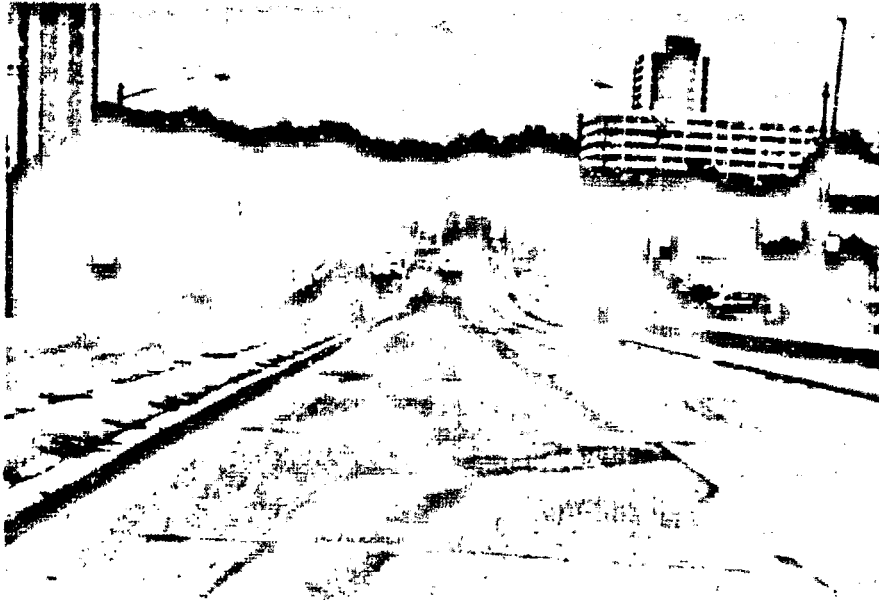
1 Pre-crash trajectory of the 1992 Ford Crown Victoria.

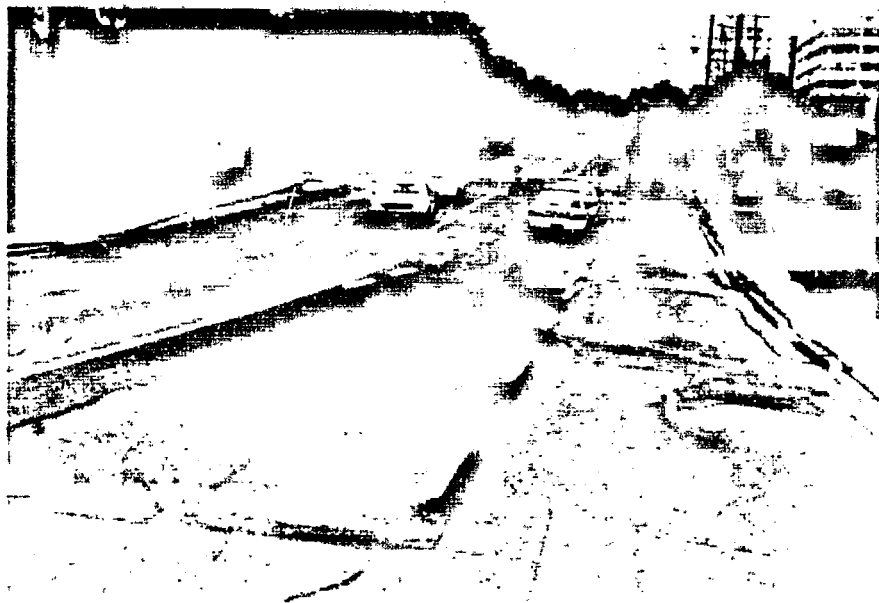
2 Counterclockwise yaw marks.

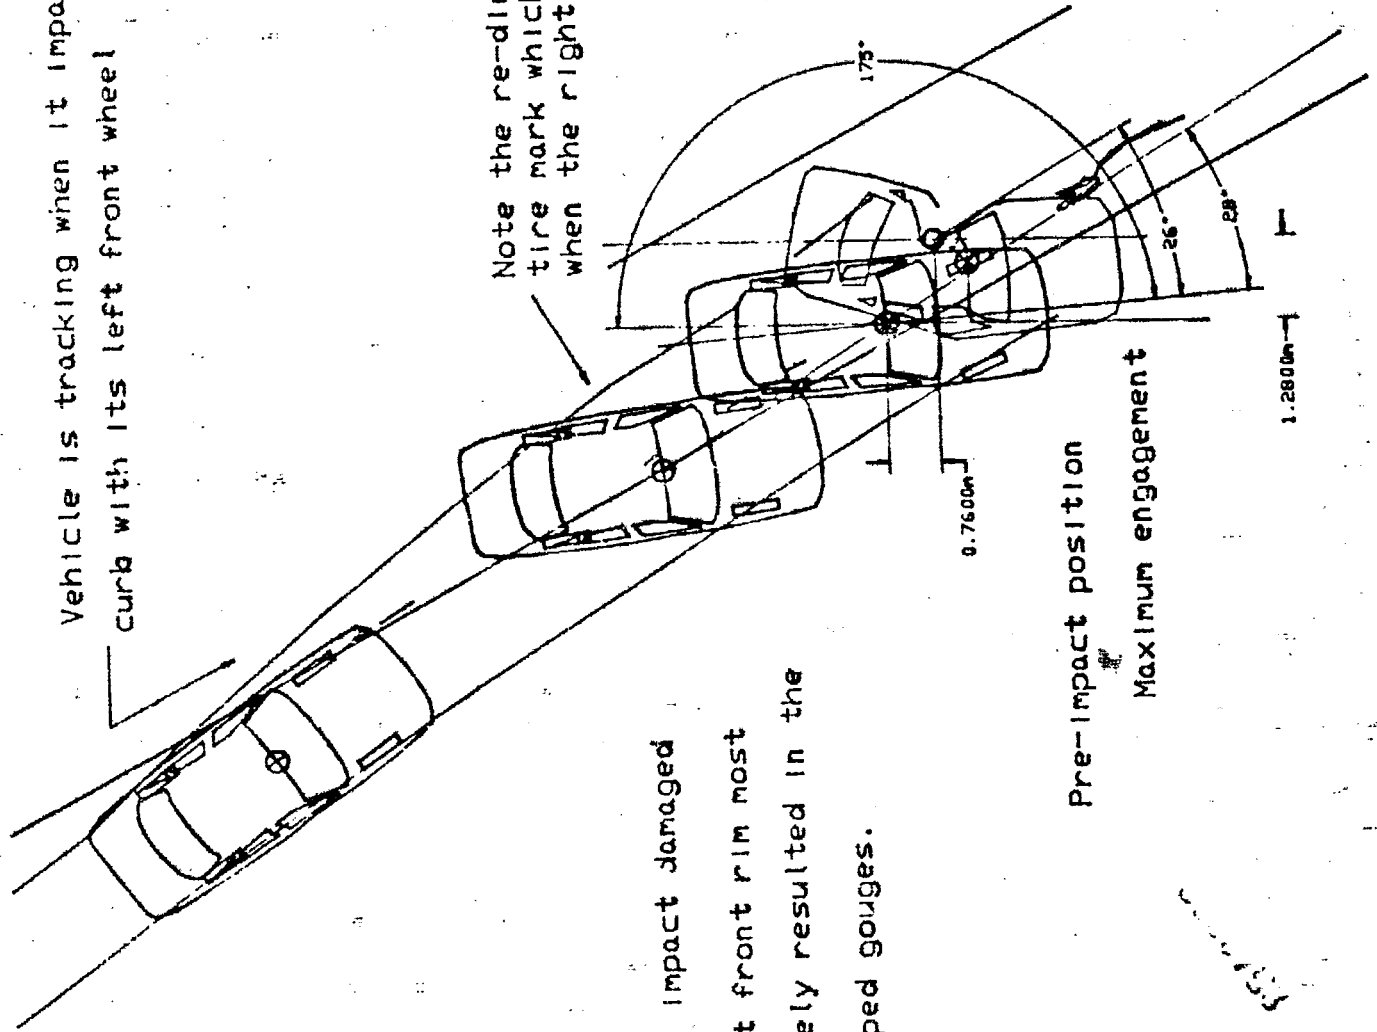
Vehicle is tracking when it impacts the curb with its left front wheel

Note the re-direction of the left rear tire mark which was likely induced when the right rear tire contacted the curb.

The impact damaged left front rim most likely resulted in the cupped gouges.
