EA94-022

**CALSPAN EVALUATION OF FORD CROWN VICTORIA POLICE VEHICLE
STEERING FAILURE ALLEGATIONS**

SYNOPSIS : CERTAIN VEHICLE MANEUVERS AT LOW SPEEDS, ESPECIALLY THOSE WHICH MAY BE ENCOUNTERED IN POLICE PRECISION PURSUIT, MAY CAUSE TEMPORARY LOSS OF POWER STEERING ASSIST AND ADVERSELY AFFECT VEHICLE CONTROLLABILITY.

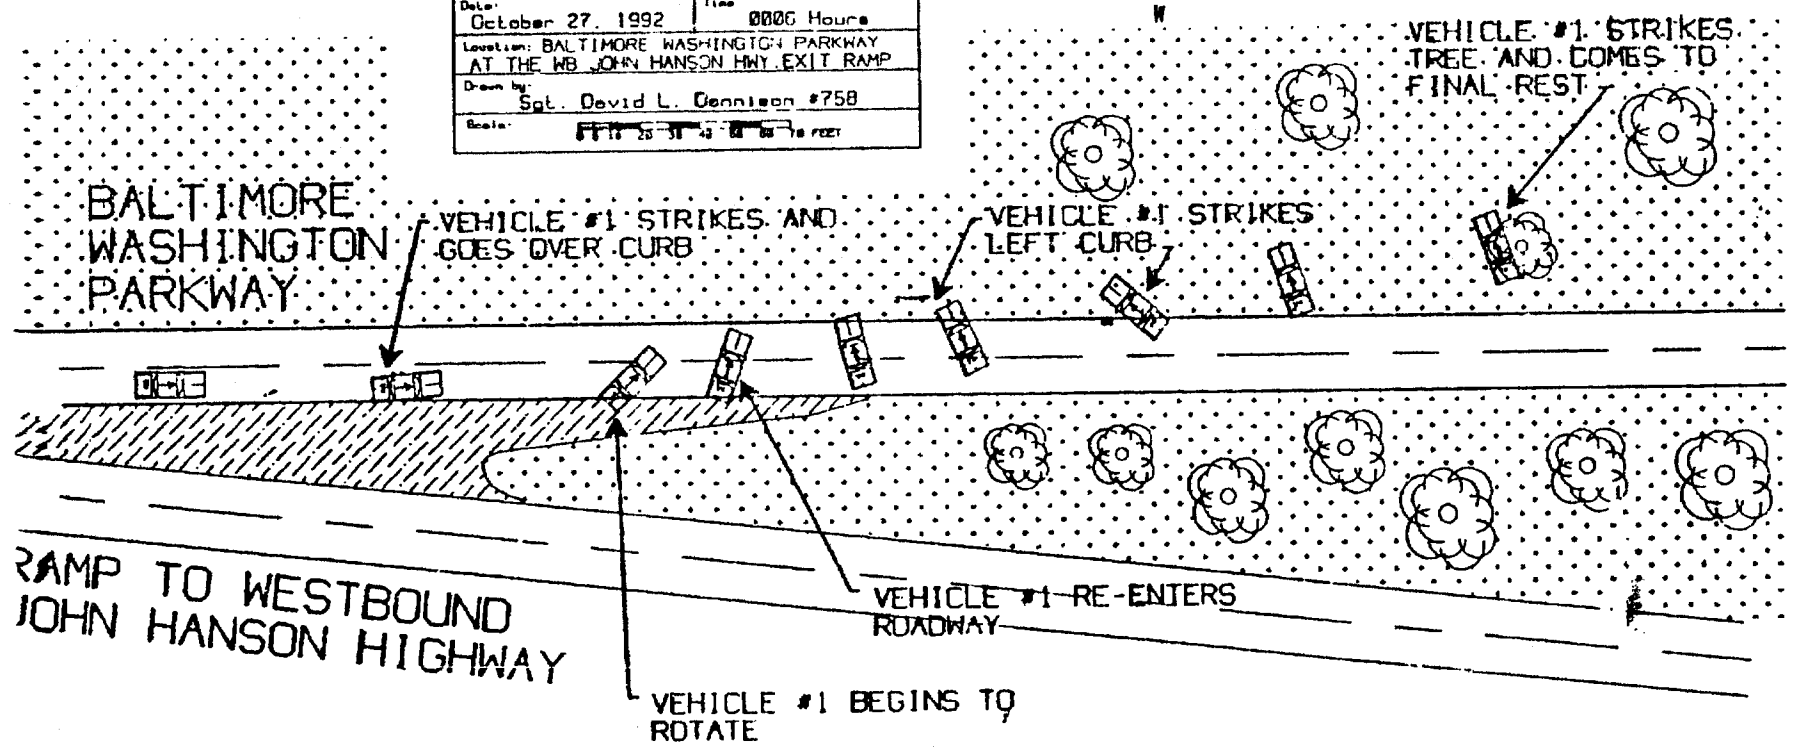
SEQUENCE OF EVENTS DIAGRAM

Just south of the exit ramp, Vehicle #1 struck a raised curb with its right rear wheel. Vehicle #1's right rear wheel went up and over this curb. This caused the frame of Vehicle #1 to drag and gouge the top surface of the curb. Vehicle #1 began rotate counter-clockwise and started sliding to the right. This caused Driver #1 to completely lose control. Vehicle #1 slid down the curb for approximately 109 feet continuing to rotate counter-clockwise. Vehicle #1 came back completely onto the southbound lanes, now sliding sideways to the right. Vehicle #1 crossed both southbound lanes of the Baltimore Washington Parkway and struck the median curb. Vehicle #1 continued over the median curb. Vehicle #1 slid southbound through the grass median and struck an oak tree with its right side. Vehicle #1 came to final rest against this tree and Driver #1 was trapped within the vehicle.

1. The primary cause of this collision is ROADWAY DEFECT. The raised curb was a traffic hazard and caused Vehicle #1 to begin rotating. This in turn caused Driver #1 to completely lose control of his vehicle.
2. Vehicle #1 was involved in a collision with a hit and run vehicle. The contributory factors of this hit and run vehicle have not been determined. The collision with the hit and run vehicle may have caused Driver #1 to initially strike the raised curb.
3. There was no evidence of contact between Vehicle #1 and the fleeing Honda.

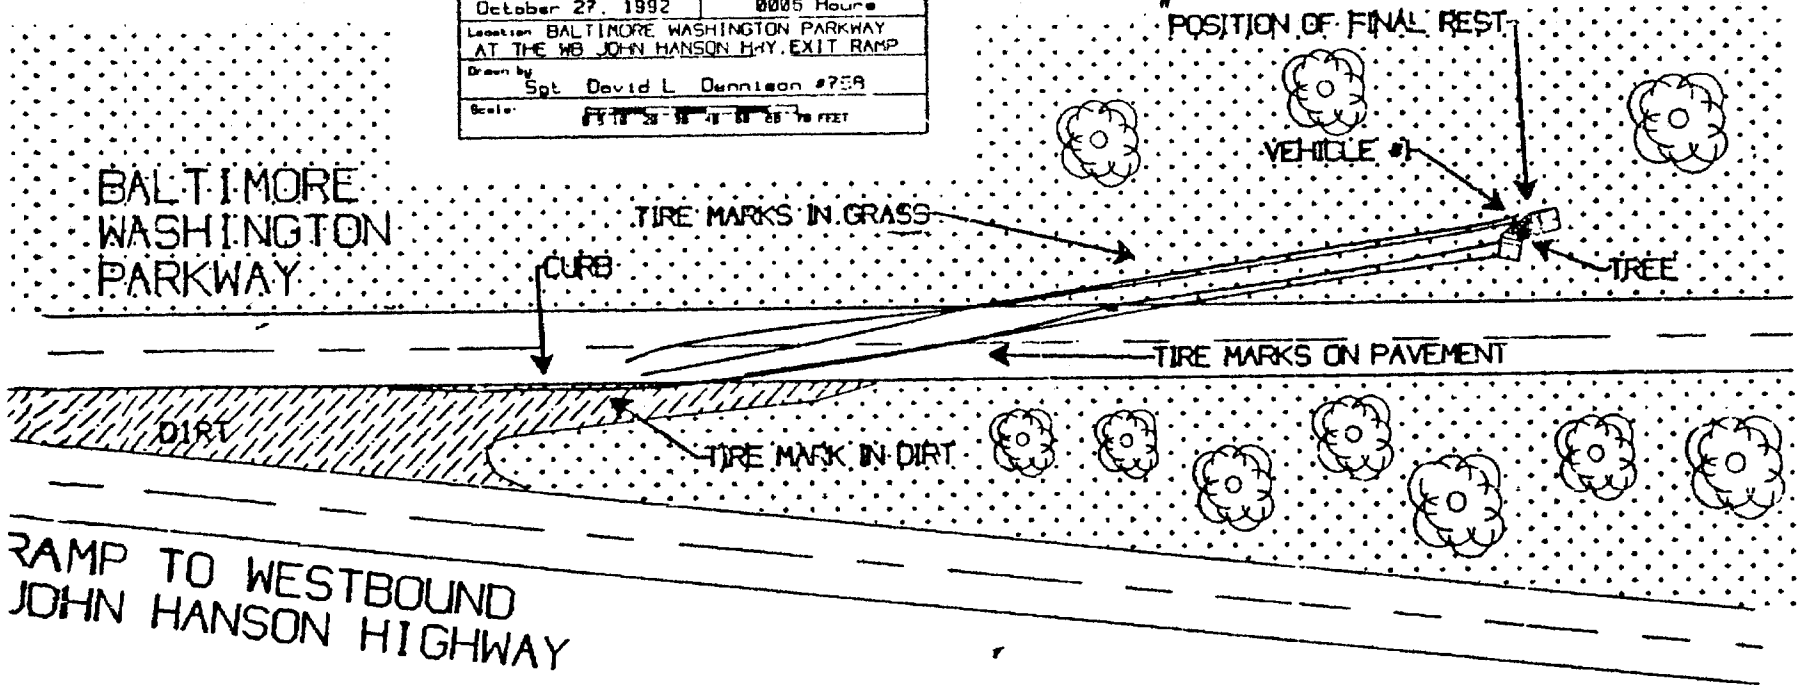
POSITION OF FINAL REST AND PHYSICAL EVIDENCE DIAGRAM

* A very deep gouge, apparently caused by the right rear wheel of Vehicle #1, was located on the median curb.

* There is a dirt area that divides southbound Baltimore Washington Parkway from the exit ramp to westbound John Hanson Highway. This dirt area is eroded from the elements and vehicular traffic. The dirt has eroded away from the outside of the Baltimore Washington Parkway's southbound right curb. This has caused the curb to protrude upward as much as 5 inches, causing a hazard to traffic.

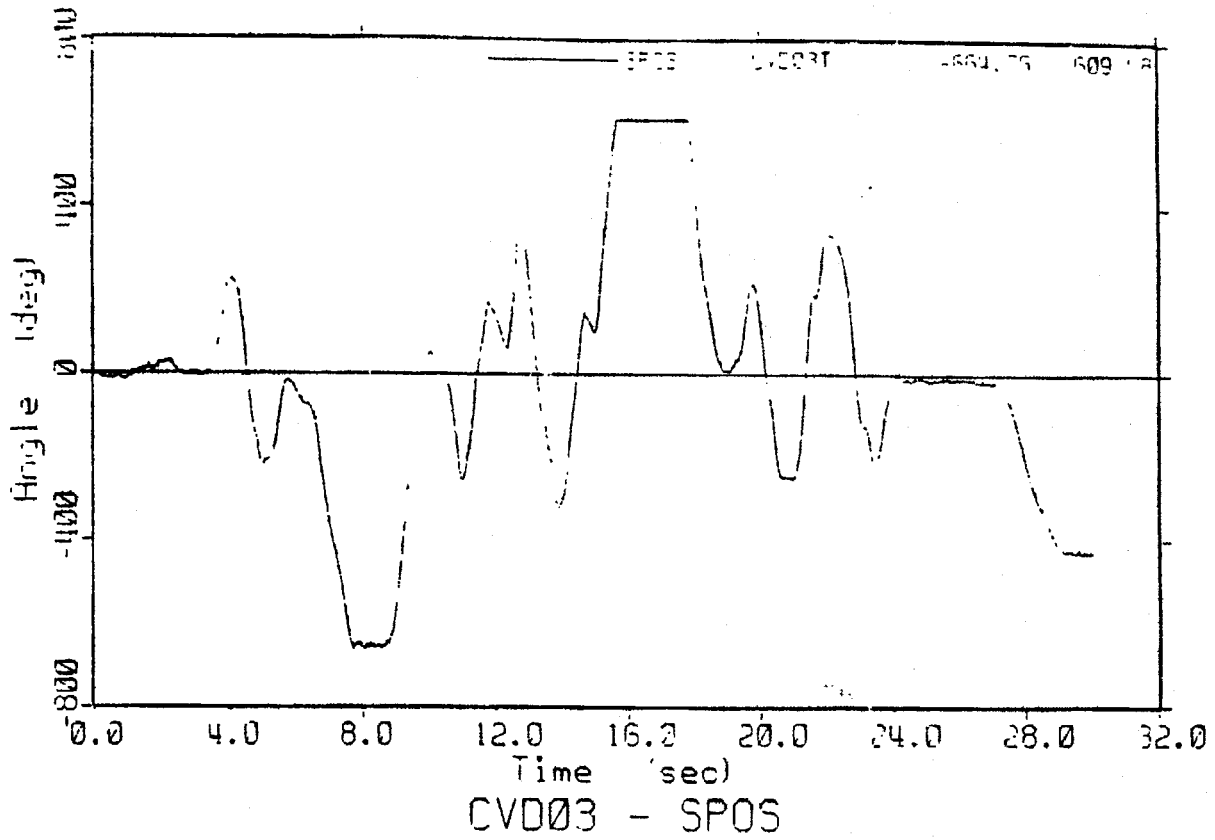
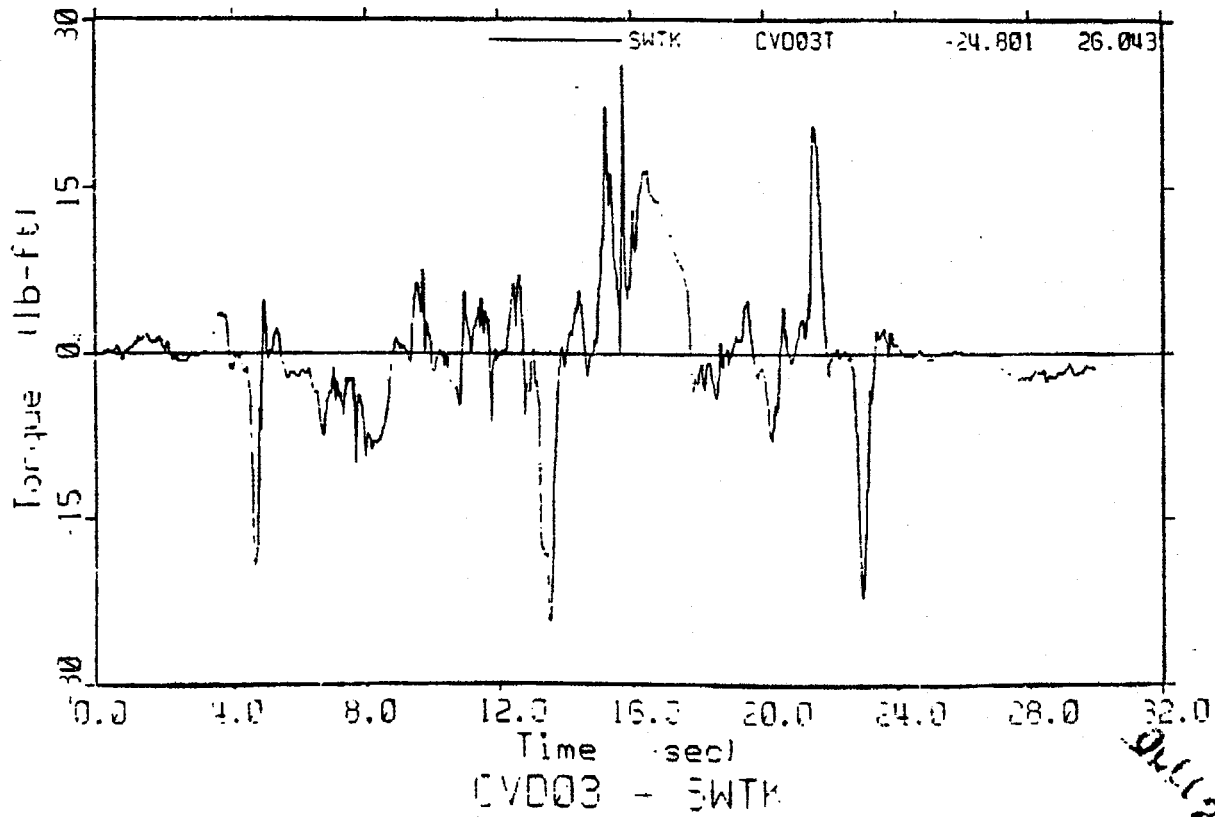
Figure 5. Steering Wheel Angle and Torque
 1992 Crown Victoria (unmodified)
 Police Vehicle (Veh. #5)

Typical data plots of steering wheel angle and torque versus time for the unmodified 1992 Crown Victoria (Vehicle 5) are shown in Figure 5; comparable data plots for the 1992 Caprice (Vehicle 3) are shown in Figure 6.

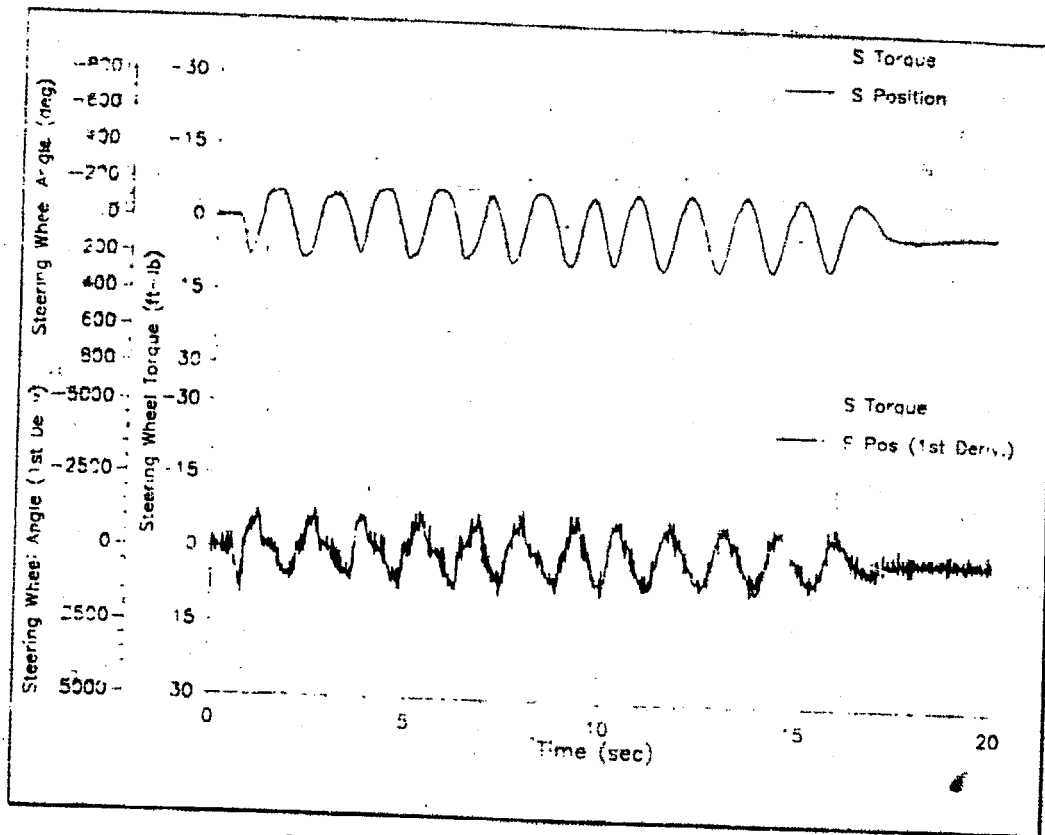
Figure 6 -Vehicle 1 Serpentine 04 Derivative

Figure 6 contains graphs of data and data calculations for Run CVS04. The upper graph is the time history of applied torque and steering wheel position plotted along a common axis. The lower graph is the time history of applied torque and the first derivative⁹ of steering wheel position plotted along a common axis. The first derivative represents the rate of change of the steering wheel position (angular velocity) with respect to time. In the upper graph the phase difference is apparent. In the lower graph there is no apparent phase difference. During the first 9 seconds the driver's perception would be that when the applied torque is zero the angular velocity is zero, and when the applied torque is increased, the angular velocity is increased. During the last 7 seconds, however, when the driver dramatically increased the applied torque, the angular velocity did not increase during periods of supertorque, but started decreasing.
