**CALSPAN EVALUATION OF FORD CROWN VICTORIA
POLICE VEHICLE STEERING FAILURE ALLEGATIONS**

CALSPAN CRASH INVESTIGATION REPORT
CALSPAN CASE NO. 94-33
VEHICLE: 1992 FORD CROWN VICTORIA POLICE UNIT
LOCATION: SCARBOROUGH, ONTARIO (CANADA)
DATE : SEPTEMBER 28, 1994

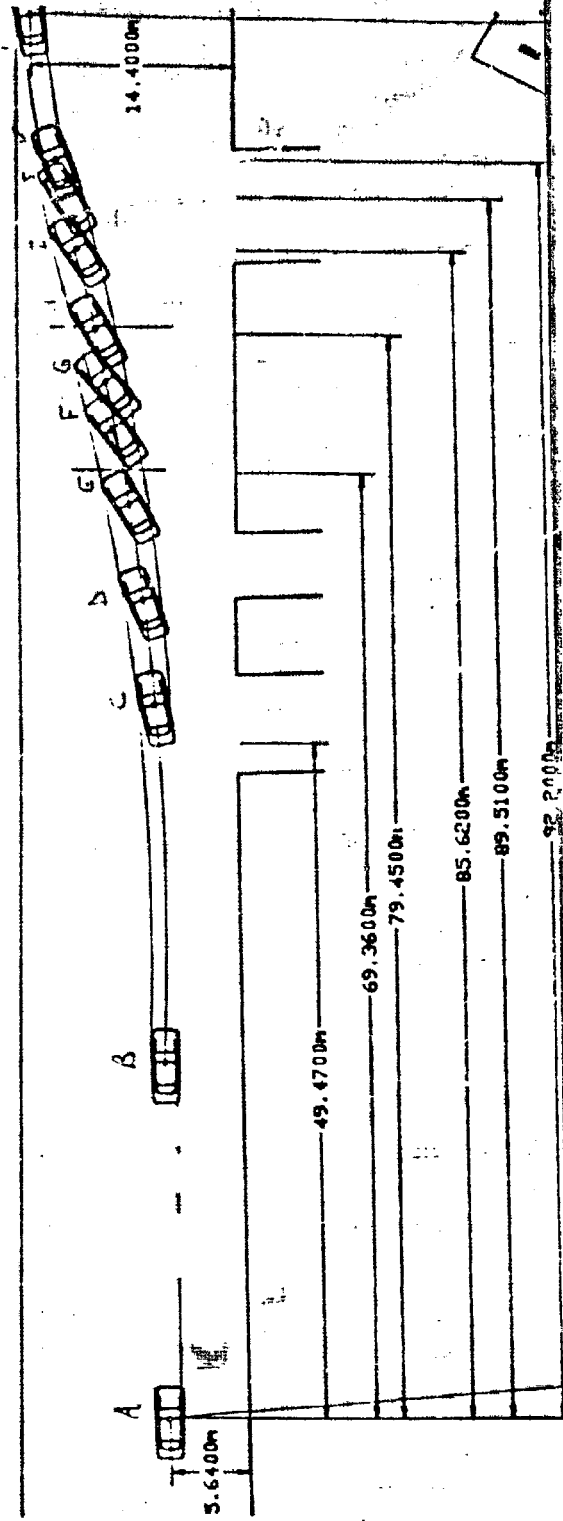
Ryerson Schematics

Vehicle is tracking when it impacts the curb with its left front wheel

The impact damaged left front rim most likely resulted in the cupped gouges.
